Inspection Report

Minerals Regulatory Program

Mine Name: Rhea-Rae		Permit Number: S/019/0064	Mine Status: Inactive		
Operator Name: Black Gold Organic Fertilizer, Inc.		Inspection Date: 07/23/2013	Permit Fees: Paid		
Inspector(s): Mike Bradley		Inspection Time: 12:00p	Bond Amount: \$25,100.00		
Others:		Weather: 92, overcast	Bond Escalation: 07/25/2015		
	Elements of Inspection		Evaluated	Comment	Enforcement

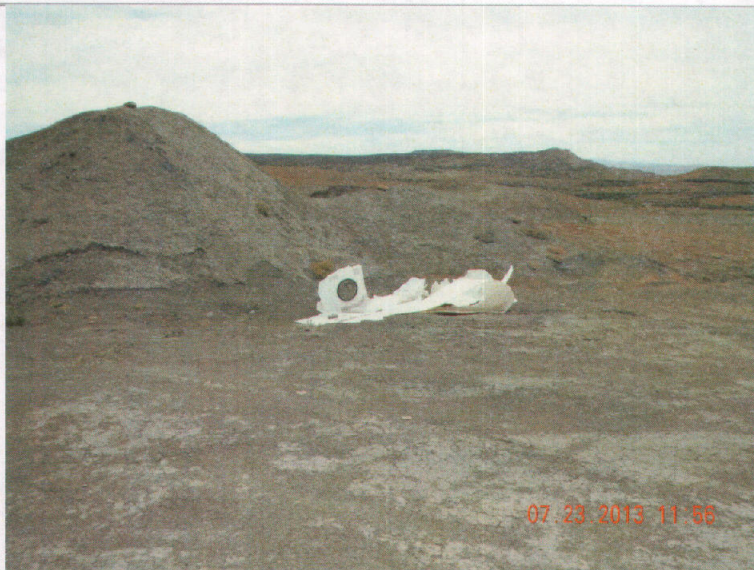
Fees are current. It appears that the facility has not been used since the last inspection. The only production facilities remaining are a pair of metal silos and some disconnected piping. The liner of the upper pond is no longer functional as some poly sheets have blown out. There is an erosion feature forming on the southwest berm of this pond and some of the bird deterrent balls have been blown out. A pile of mixed waste and debris is located near the two silos that includes wood, plastic, metal, 5-gallon pails and a couple of 55-gallon poly drums, one on its side with an associated 5-gallon pail with viscous black material leaked onto the ground. Another loose 55-gallon drum is lying on its side northwest of the silos. None of the drums are labeled. An unknown type of large white poly container has disintegrated into shards and is lying on the ground southwest of the silos.

Photo 1: Shattered poly container

If no longer intended to be used, as stated in the previous inspection report, the site should be fully reclaimed as soon as possible. All materials should be removed and the area regraded to remove impoundments and re-establish natural drainage. Spilled materials should be removed and any stained soils cleaned up and properly disposed of.

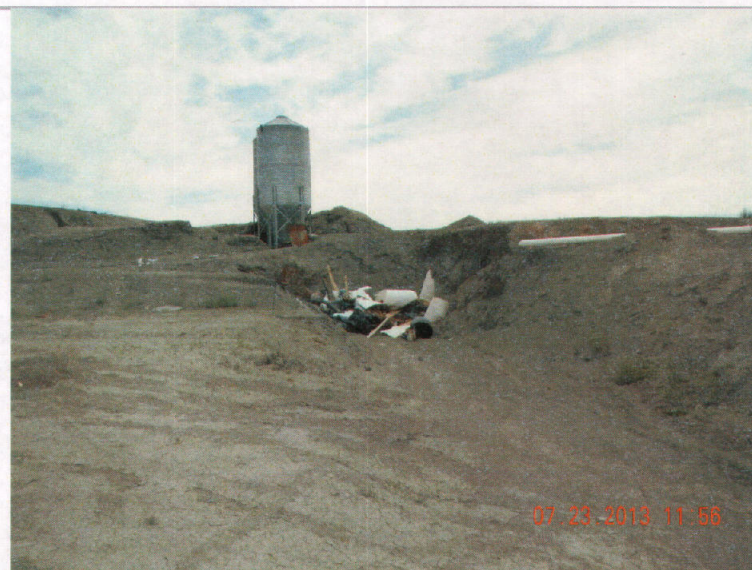
Photo 2: Silos, debris pile, disconnected pipe

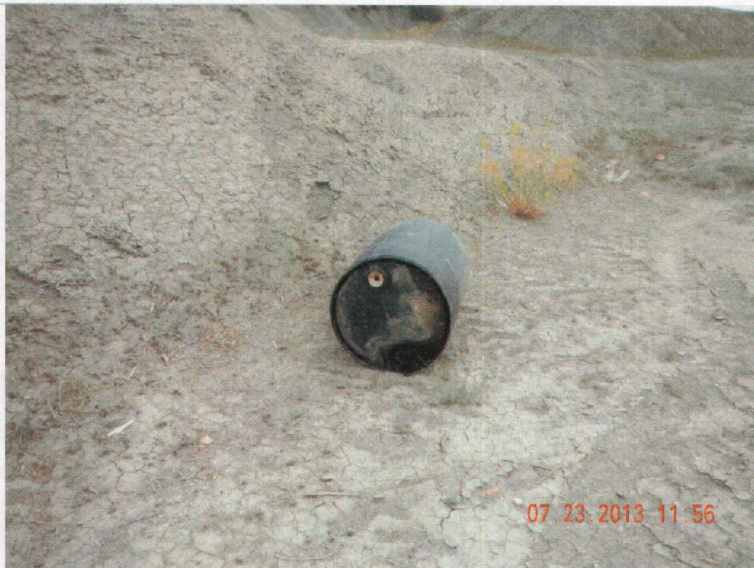
Photo 3: Unlabeled 55-gal drum on side

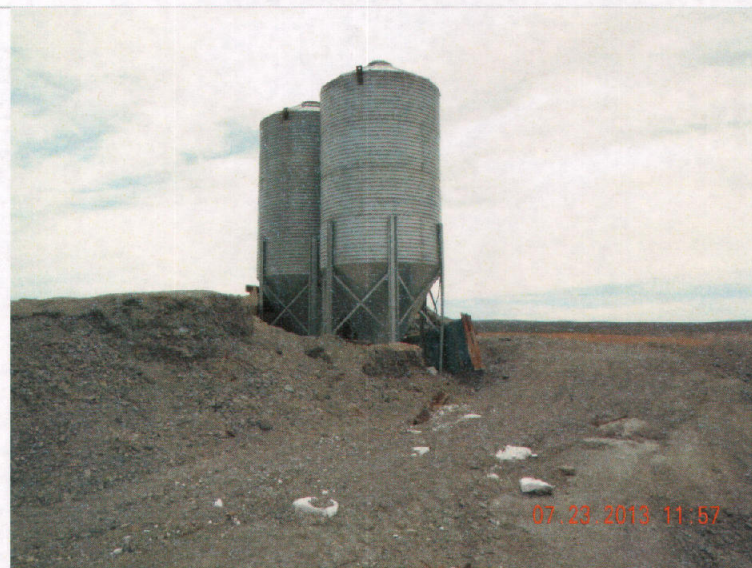
Photo 4: Pair of metal silos

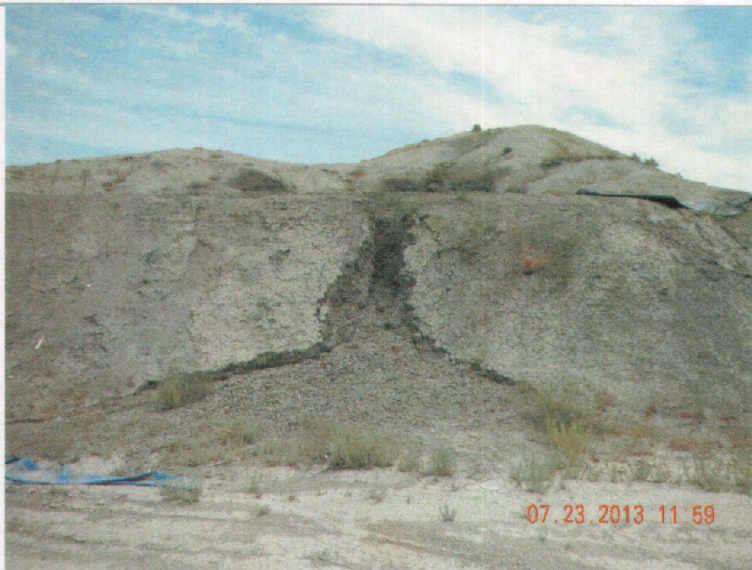
Photo5: Erosion forming on upper pond

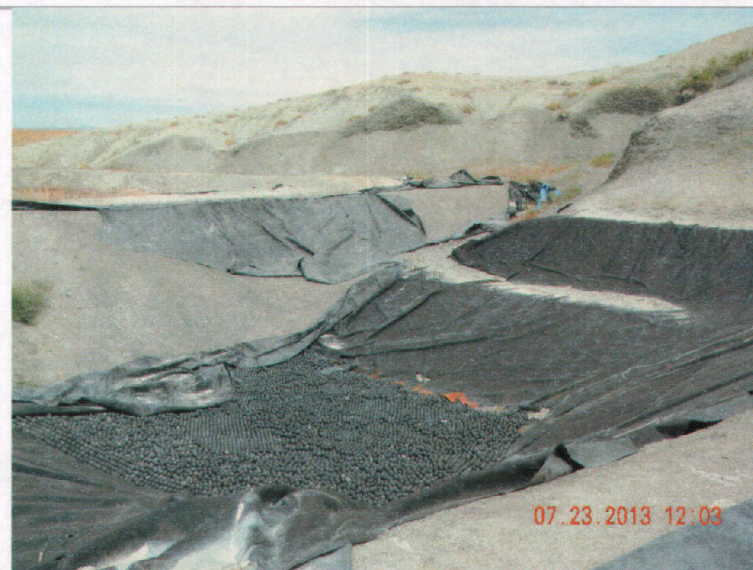
Photo 6: Upper pond liner displaced

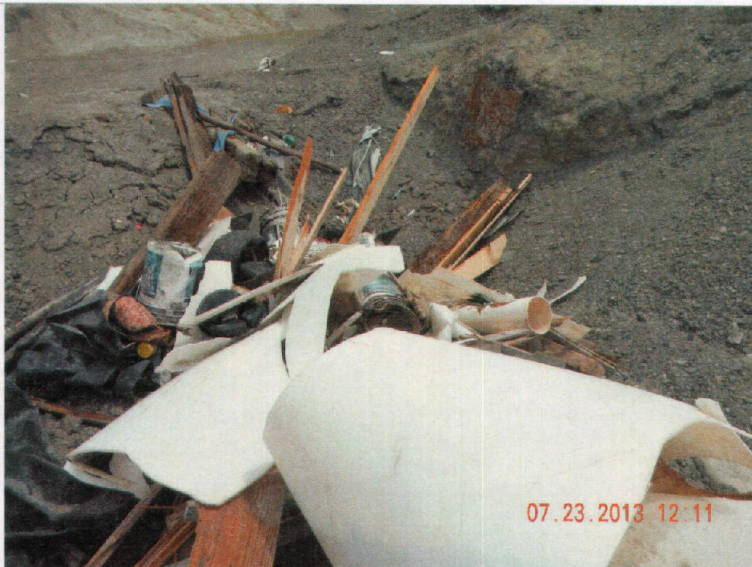
Photo7: Debris pile near silos

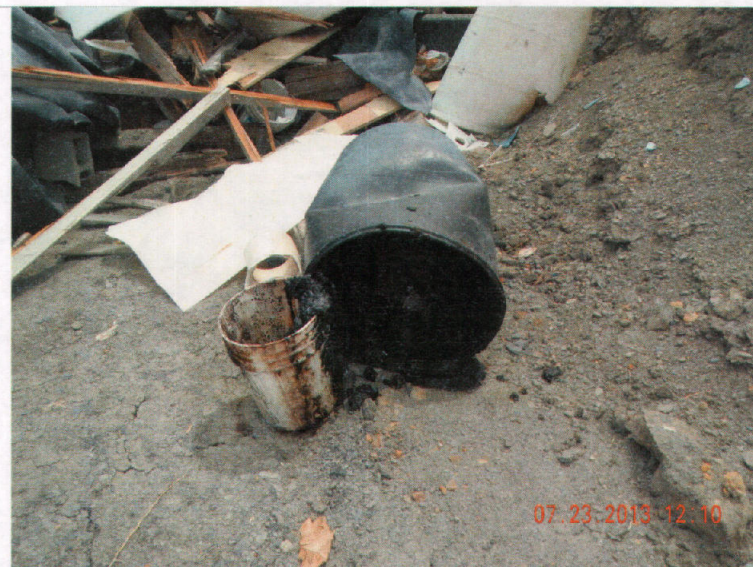
Photo 8: 55-gal drum and 5-gal pail with spilled black material
